Re: Drainage & Erosion Control

PROJECT ASHBRIAR

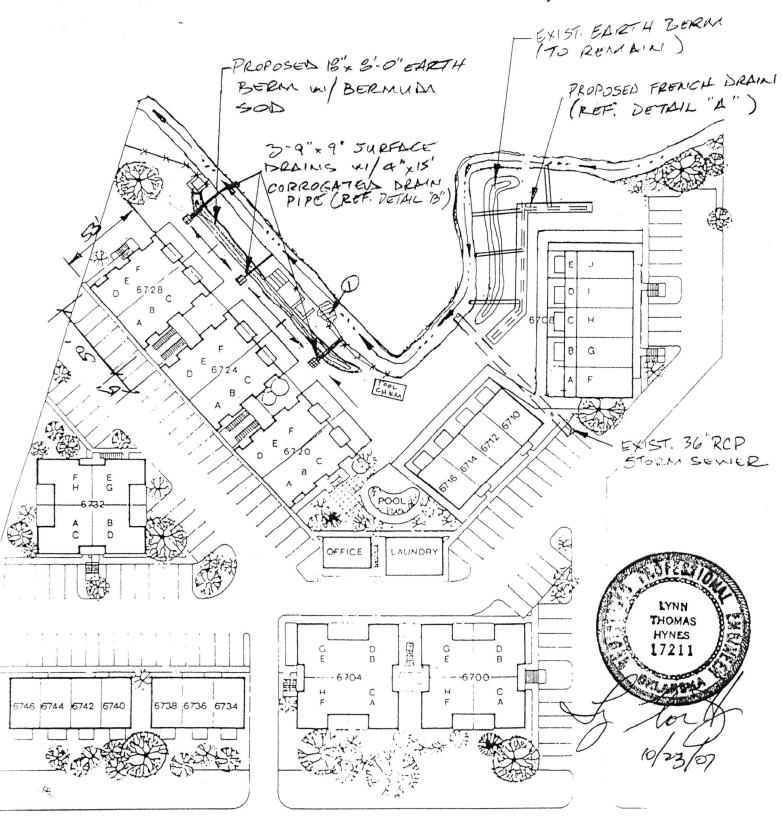
LTH, ltd. Ok CA 3573 DARED OF CHANNEL SLOPE INSTABILITY, REMOVE LARGE ROCK & DEBRIS UPSTREAM & ADJACENT TO THIS AREA TO REQUEE TURBULENT FROM CONDITIONS & ASSOCIATED SCOUR. REGRADE CHANNEL SLOPE, ADDING CLAY-RICH SOIL AS REQUIRED. PLACE 18' RIP-RAP ON REGRADED SLOPES & TOD WITH SOIL TO FILL VOIDS & PROMOTE VEGETATION GROWTH,

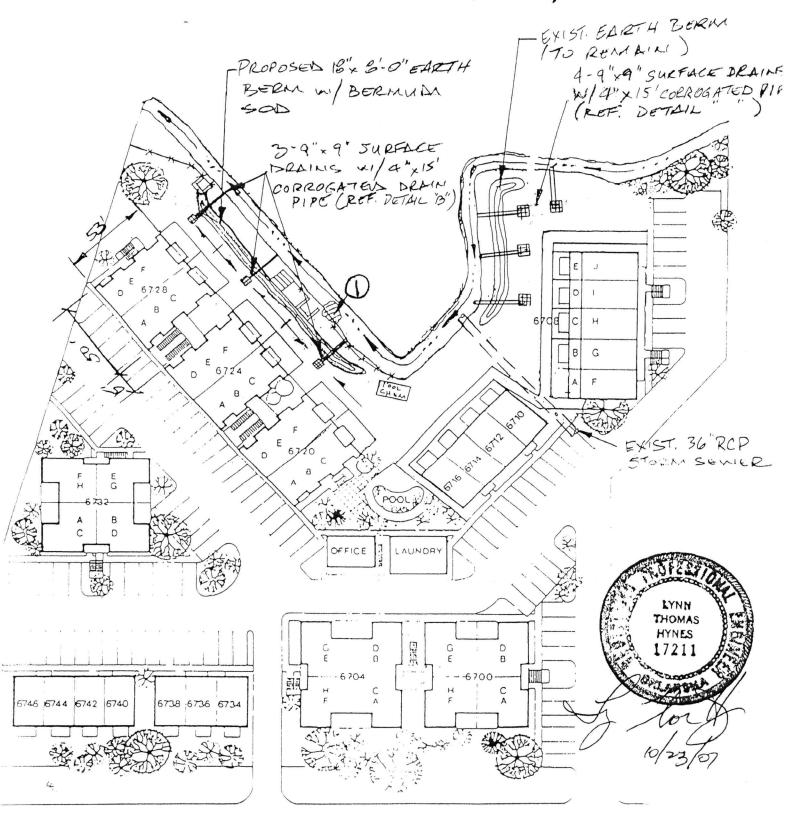
DARED OF CHANINER SLOPE INSTABILITY, REMOVE LARGE ROCK & DEBRIS UPSTREAM & ADJACENT TO THIS AREA TO REPULE TURBULENT FROM CONDITIONS & ASSOCIATION SCOUR. REGRADIC CHANINER SLOPE, ADDING CLAY-RICH SOIL AS REQUIRED. PLACE 18' RIP-RAP ON REGRADED SLOPES & TOP WITH SOIL TO FILL VOIDS & PROMOTE VEGETATION GROWTH,
